Barn History

The Brunn Barn located on the Woodstock Fairgrounds was originally constructed in 1822. It is representative of the typical barn construction, layout and materials used at that time in New England. Barns were and remain a necessary part of farming to house livestock, feed and equipment.

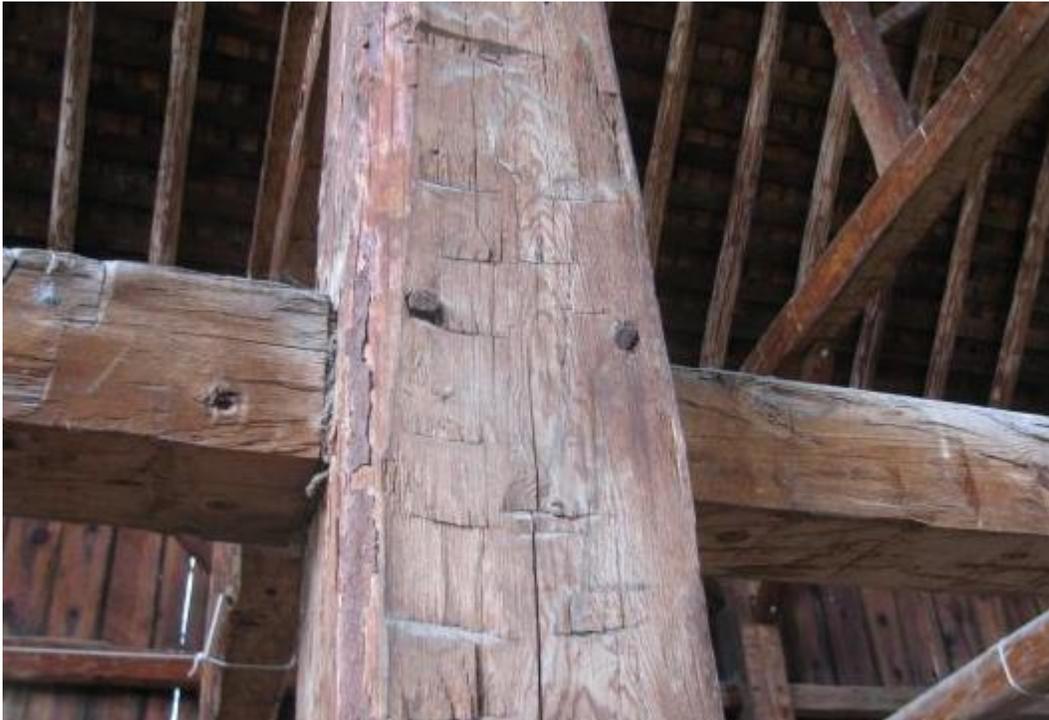
Mortise and Tenon Joint

Materials for the barn construction came from local forests. Timber framing with vertical sideboards was the common style. Harvested trees were hewn or sawn to form the beams required for the post and beam framework of the barn. These heavy, squared off beams were then fitted and joined by mortise and tenon. A simple, yet strong method of tying beams together. The joints were secured by the wooden pegs you can see as you look around the barn. This construction method resulted in a barn that could bear heavy weight while maximizing interior space.

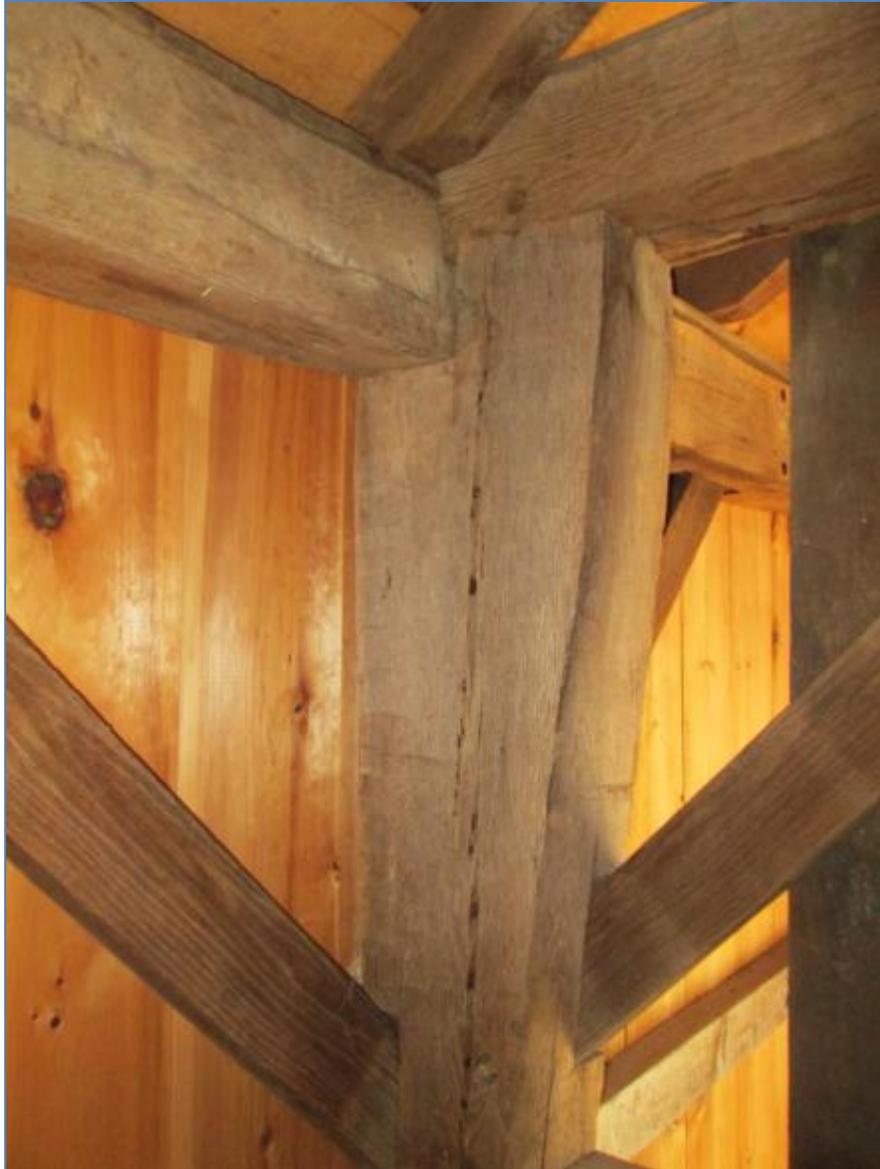
Gunstock post/joinery in the Brunn Barn

A specific type of post which was sometimes used in timber frame structures is referred to as “Gunstock” or “Musket Stock” due to its resemblance in shape to an inverted rifle stock. A “Gunstock” post has an increased size/thickness at the top to provide added bearing surface. This provided extra strength and support for the intersecting joinery. Although not commonly found any longer, you can see this type of post was used on the outside walls of the Brunn Barn.

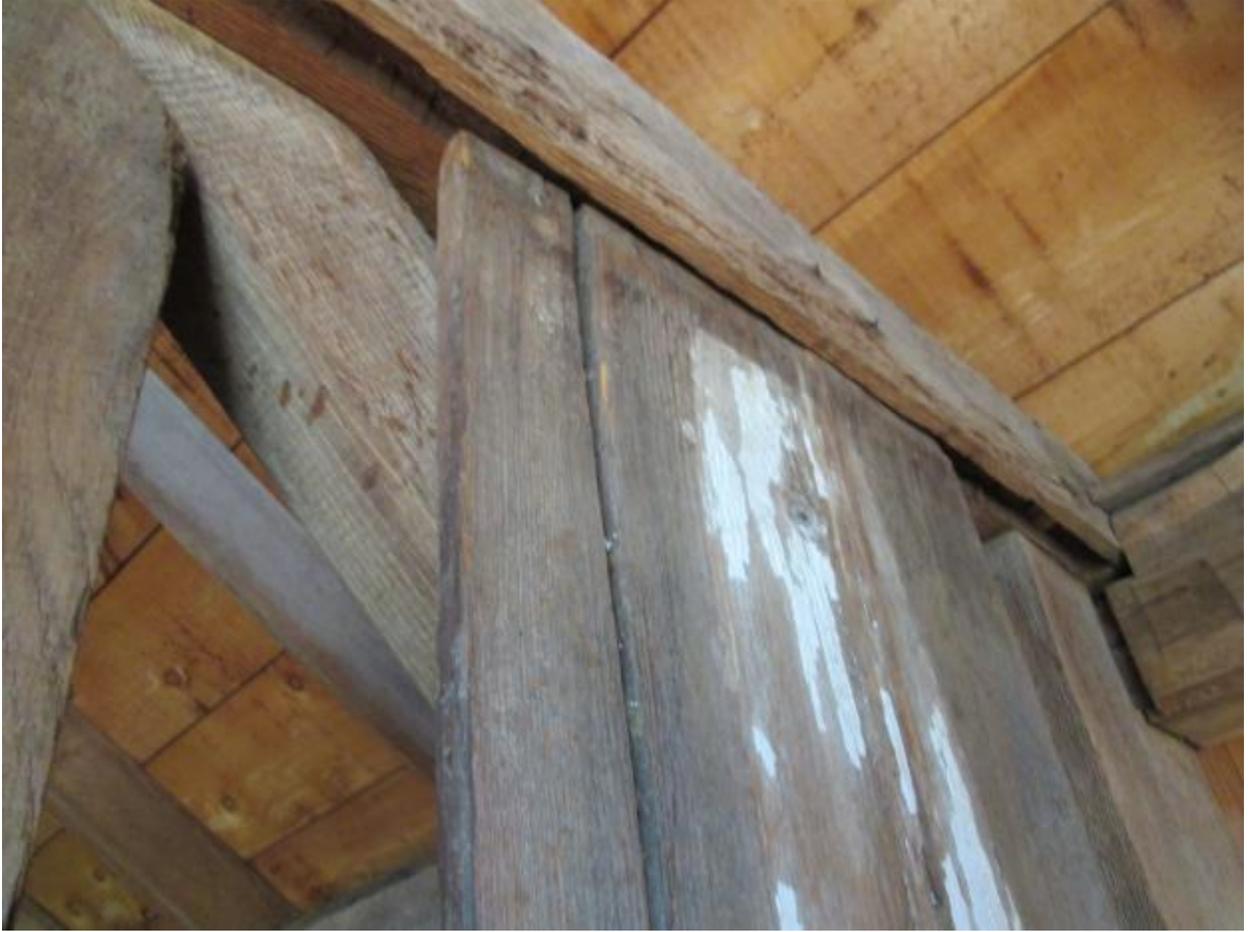
Beam is grooved to accept tops of sidewall boards

Another unique construction feature of the original Brunn Barn can be seen near the stairs at the West side of the barn. The upper horizontal beams on the sides of the barn were grooved to accept the tops of the vertical sidewall boards. This provided a solid fit for the tops of the boards while providing protection against water penetration and eventual wood rot.

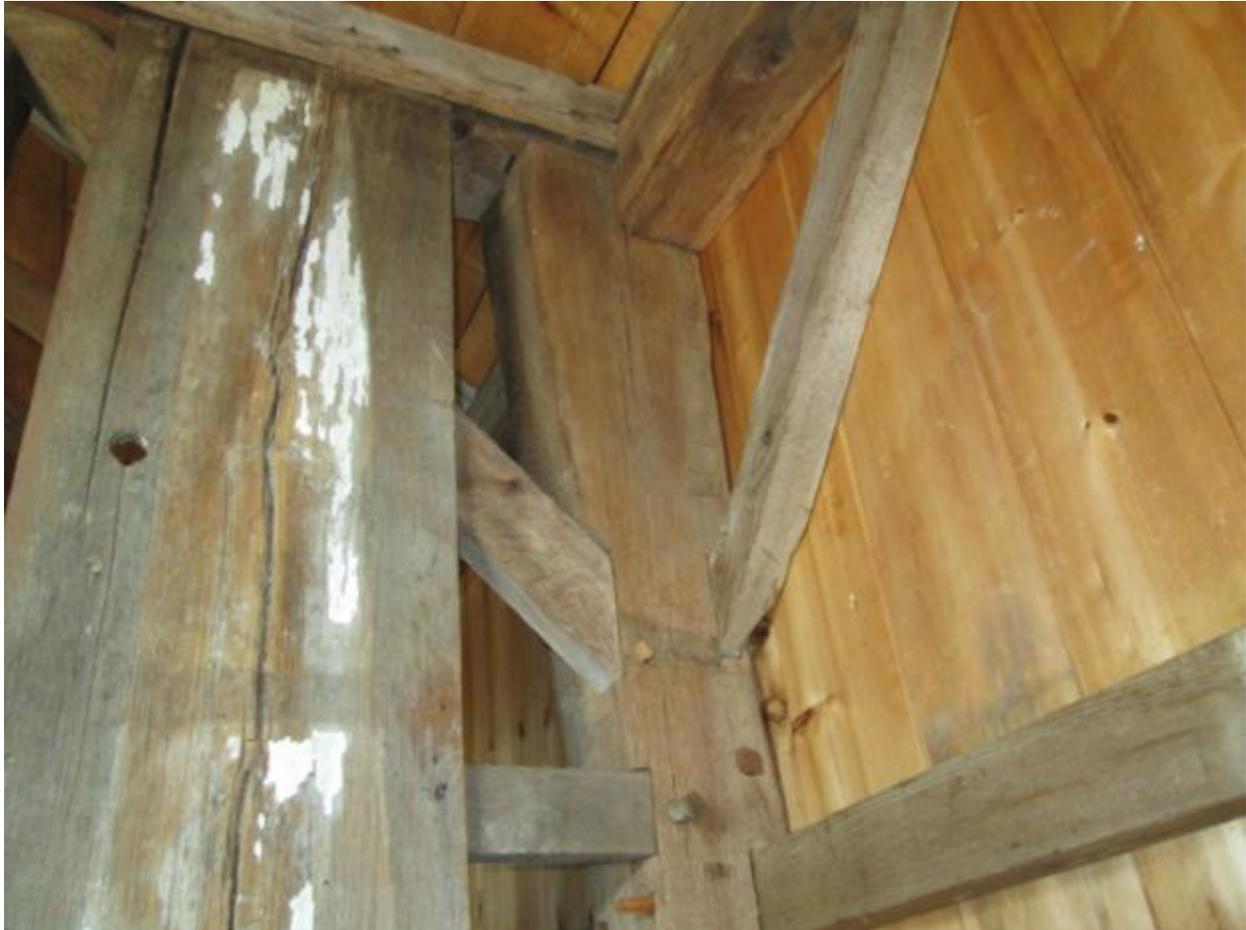
Both the grooved fit of the boards and the Gunstock Post can be seen above.
